GROUND INVESTIGATION FACTUAL REPORT

LAND AT CAMISCAN FARM, CRAIGIE, KILMARNOCK SOUTH

NOVEMBER 2022

**RAEBURN DRILLING AND GEOTECHNICAL
(NORTHERN) LIMITED**

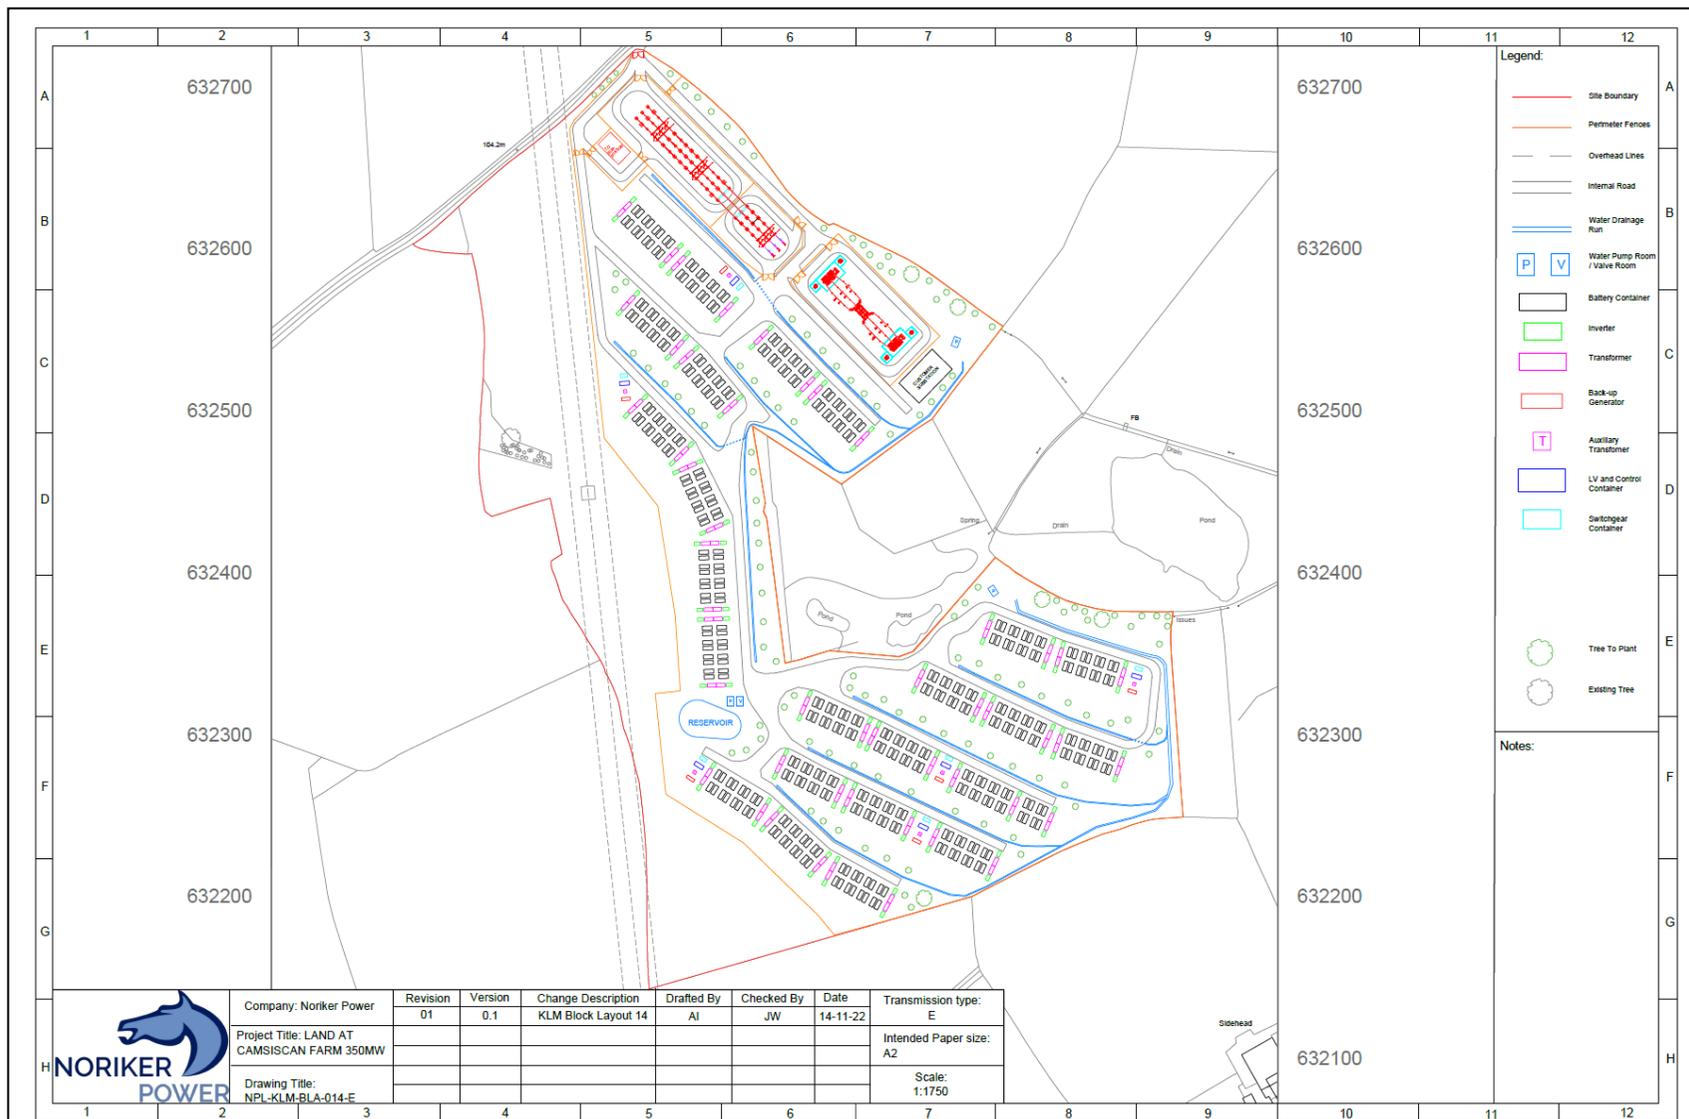
FIGURE A1 – PROPOSED SITE DEVELOPMENT

Client:	Noriker Power
Project:	Land at Camiscan Farm, Craigie, Kilmarnock South
Title:	Proposed Site Development
Date:	November 2022

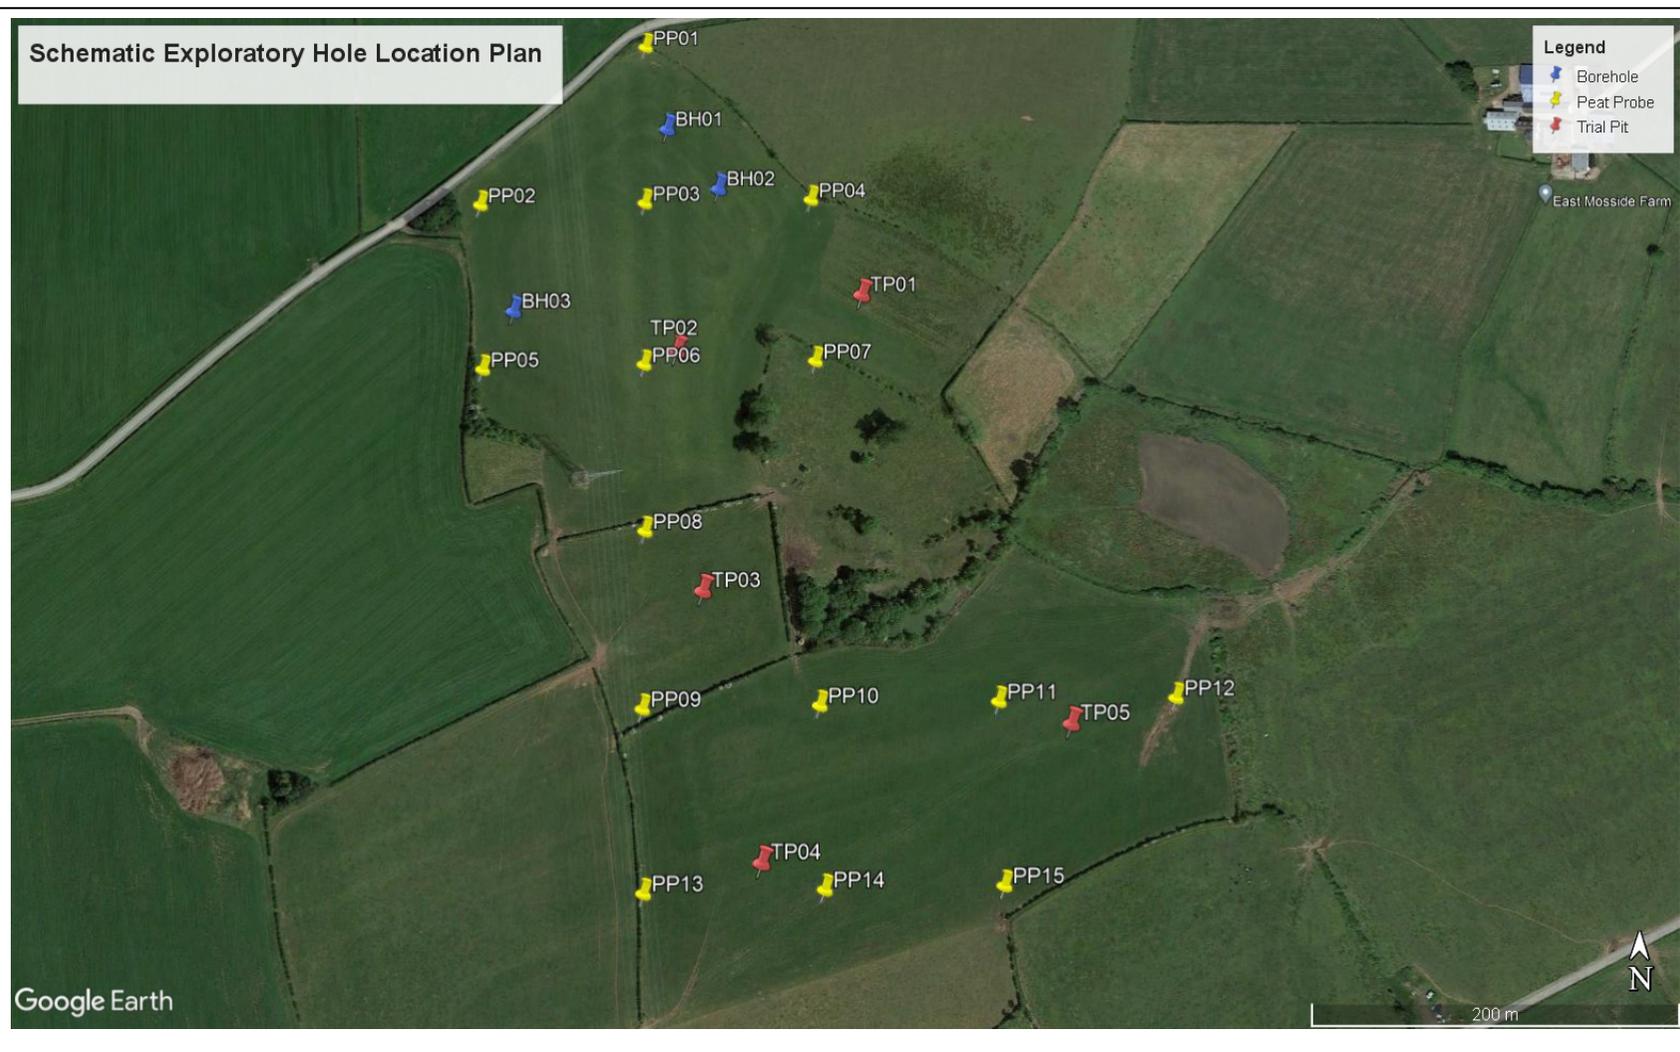
FIGURE A2 – EXPLORATORY HOLE LOCATION PLAN

Client:	Noriker Power Ltd
Project:	Land at Camiscan Farm, Craigie, Kilmarnock South
Title:	Exploratory Hole Locations
Date:	November 2022

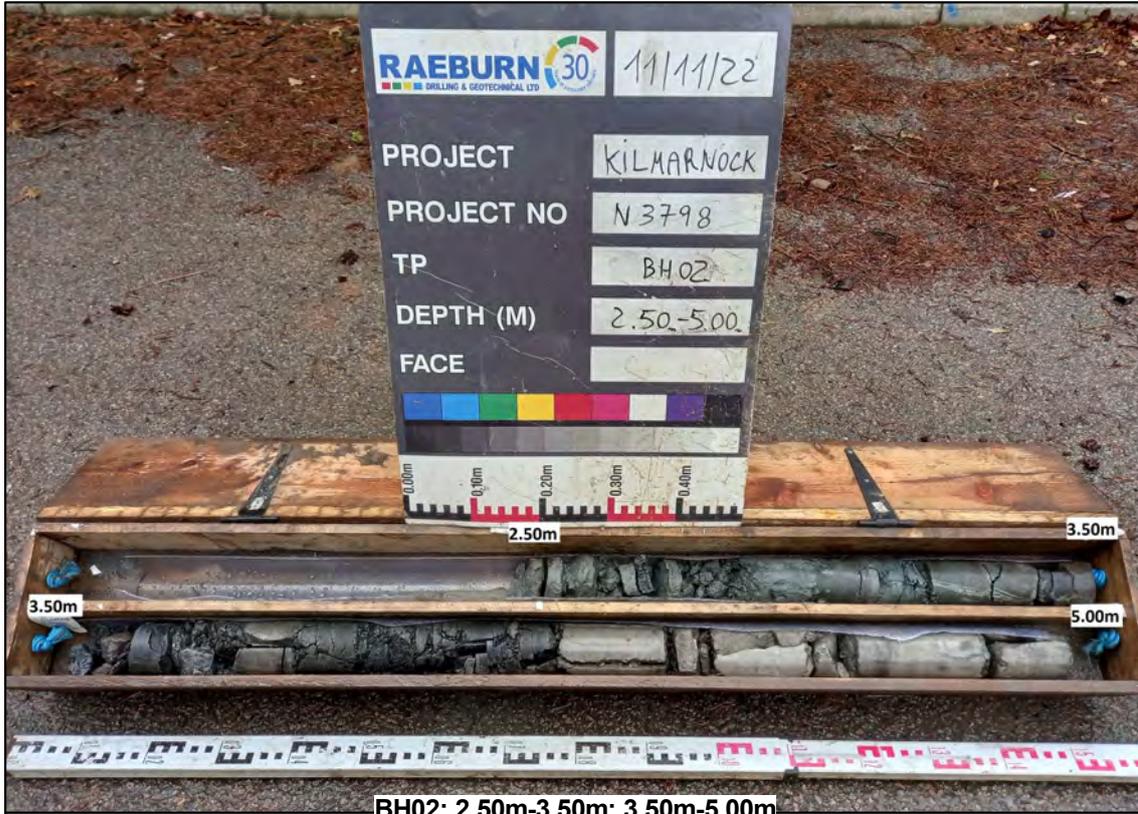
BH02: 2.50m-3.50m; 3.50m-5.00m

2.20	D	2.20	SPT=59 10.10/13.15.15.16					100.87	2.20	Very weak to medium strong grey and light brown CLAYSTONE. Rock is moderately weathered (locally highly weathered) and highly fractured. Fractures are: predominantly 0-90 degrees; discordant; close to very close spaced; rough to smooth; planar (locally stepped); surface deposit of grey sandy clay noted along fracture surfaces.between 2.50m and 3.50m depth - occasional quartzite veins (4mm thick). Orientation ranging from 0-45 degrees.

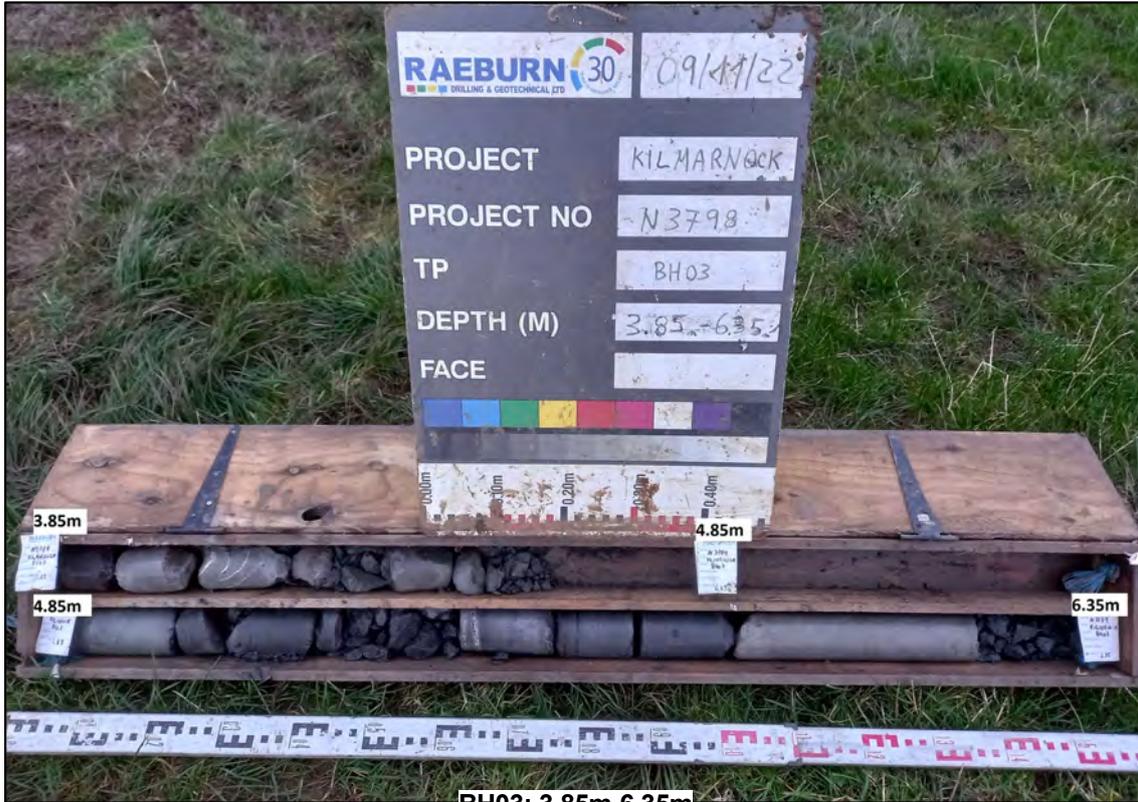
BH03: 3.85m-6.35m

Bedrock was found to comprise very weak to medium strong CLAYSTONE and was noted to be moderately weathered with localised fresher core also evident. The claystone was highly fractured with fracture index of >20 fractures per metre generally recorded. The claystone was also locally recorded as non-intact with close to very close spaced discontinuities noted.
